Overview of the Accident

On September 12, 2004 at approximately 1345 hours seven members of California Department of Forestry and Fire Protection (CDF) Columbia Helitack (Copter 404) crew had to take emergency action when a sudden wind shift and fire flareup overran their position. Three Firefighters suffered minor injuries and Firefighter Eva Schicke was entrapped and killed.

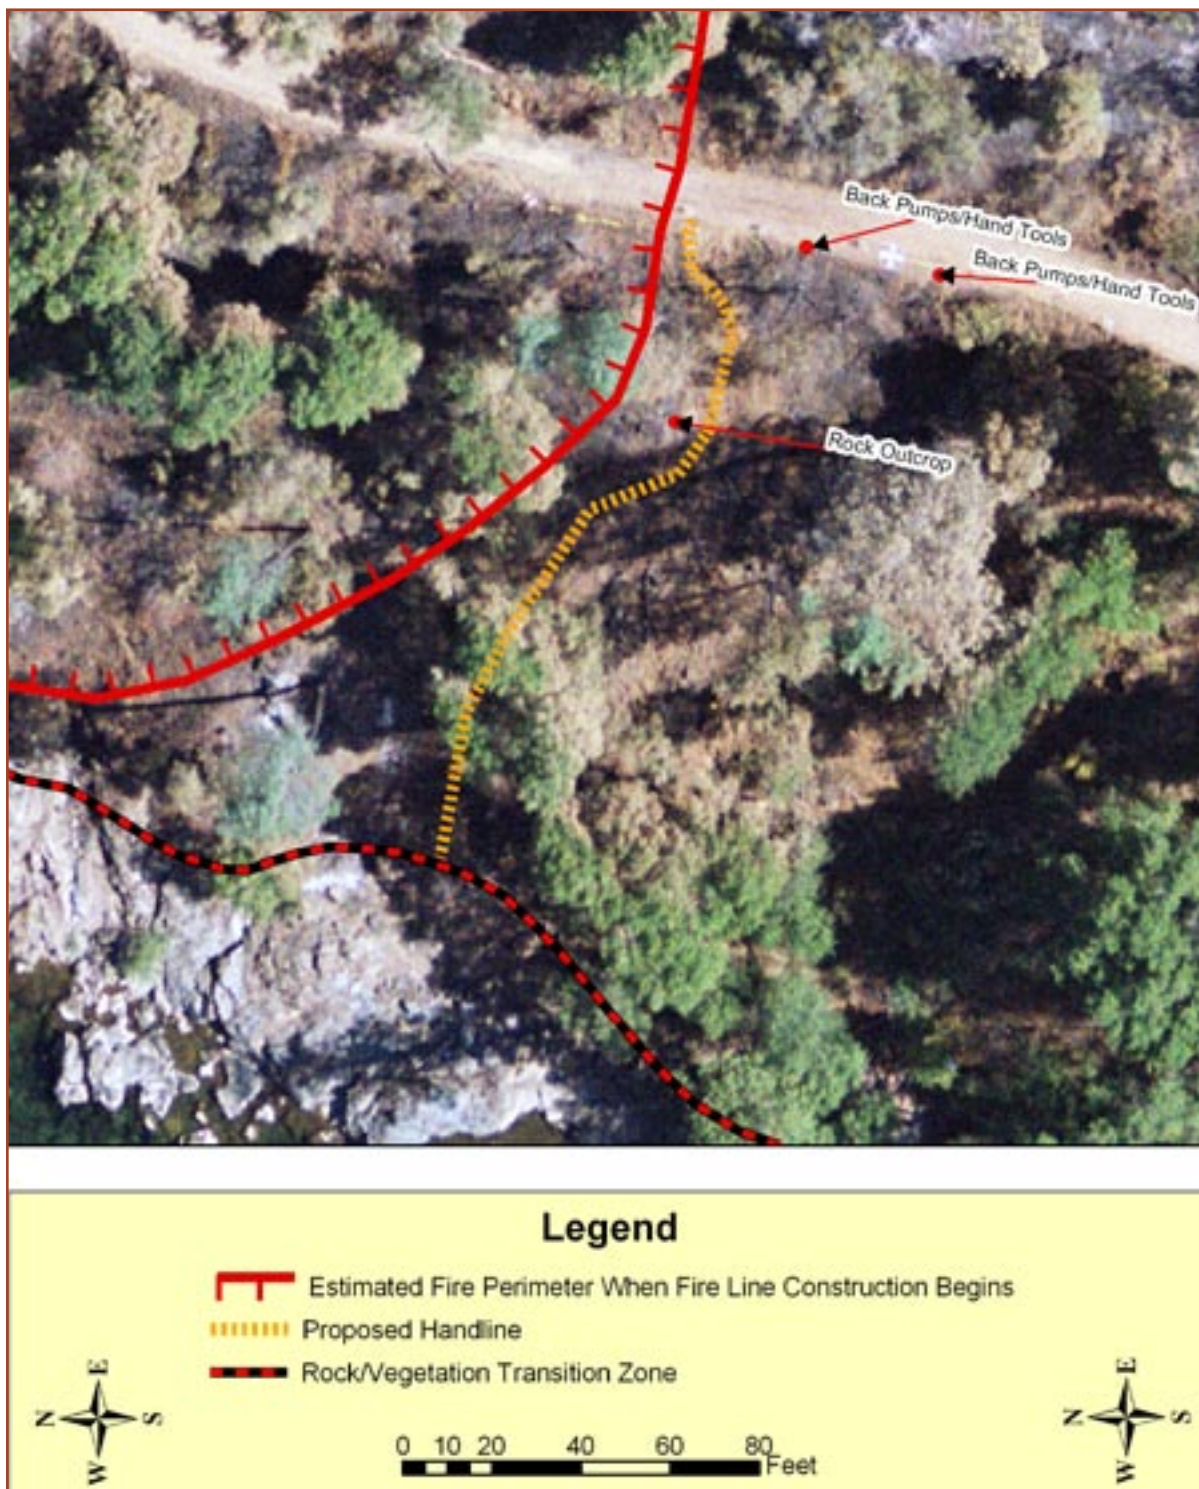
Planned fire line construction.

require constructing underslung line if they went direct. HC Winger made the determination that constructing a scratch line from the road downhill to the river would be simple and quick to accomplish. His plan was to construct indirect line parallel to the fire edge and then cut off the underslung portion by dropping straight down to the river and firing out the intervening fuel.

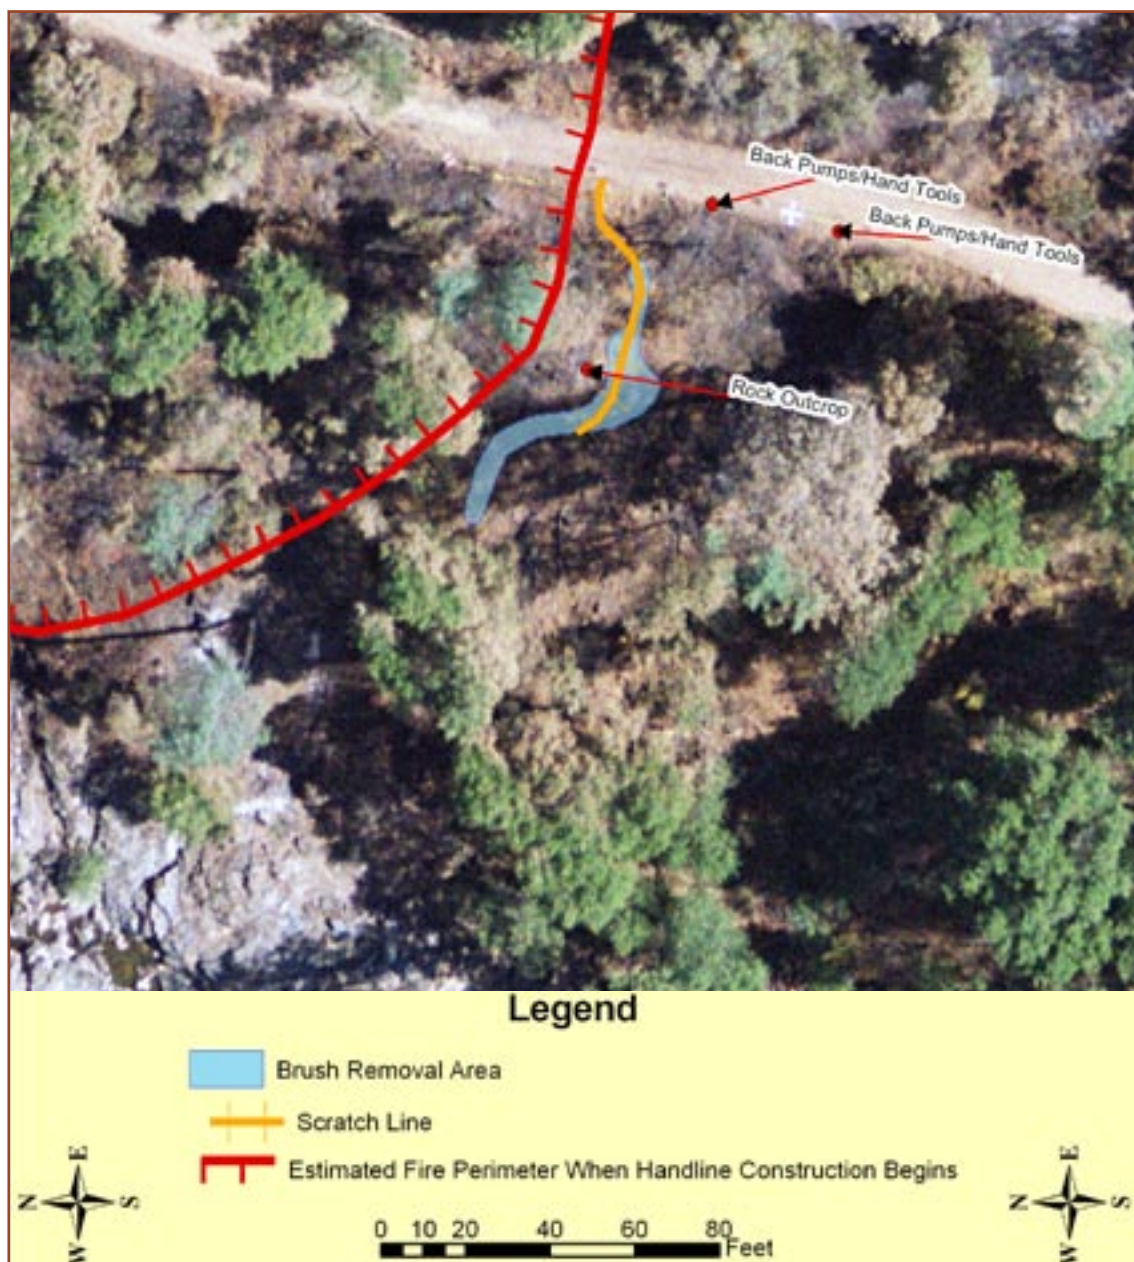
Fire line construction prior to flareup.

At approximately 1340 hours the crew members began building handline downhill through a 30- to 50-foot wide “grassy opening” with scattered brush fuels under an oak and pine overstory. They used the chainsaw and hand tools. The fire was backing into a steady 3 to 5 mph up-canyon wind towards the crew. FF Fraser and FF Agustin had reached a point approximately 2/3 of the way down the slope (roughly 30 feet above the rocks at the high water level of the river) and were running out of brush to cut. They moved very quickly since there was only scattered brush. The cut brush was thrown into the green, creating a brush-free zone for line construction. HC Winger and FF Andahl had cut a scratch line below a rocky outcropping, 80 to 100 feet down-slope from the road. FF Schicke and FF Boatman were improving the scratch line and FF Neveau was using a fusee to burn out the intervening fuel starting at the road. FF Neveau had fired from the road to FF Schicke’s position, 25 to 35 feet below the road. According to their observations, the firing operation was “pulling into the fire’s edge nicely.”

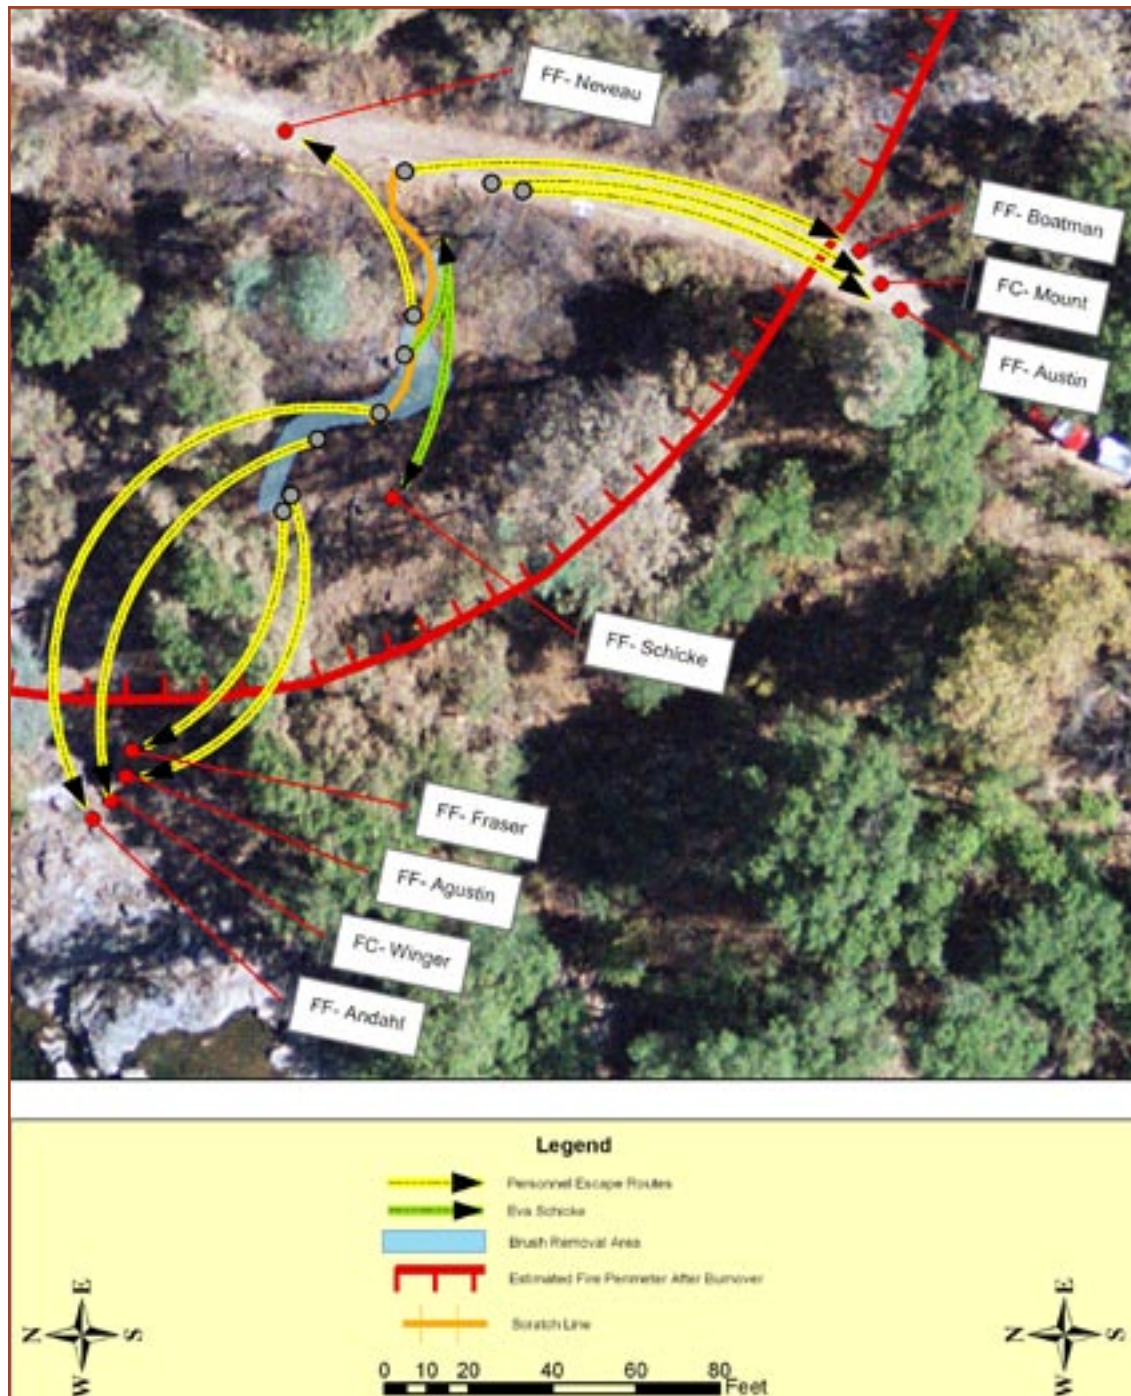
Post Flareup Personnel Locations

- FF Neveau scrambled up the fireline towards Lumsden Road. He looked over his shoulder and saw FF Schicke scrambling directly behind him. He felt intense heat coming from below and thought he was starting to burn. FF Neveau heard FF Schicke screaming. He last saw FF Schicke when they were within 5 to 10 feet of the road. This was the last time FF Schicke was seen alive.
- As the flames hit the road FF Neveau rolled over the lip of the road within the oncoming flame front and rolled across to the cut bank. FF Neveau moved up Lumsden Road into the black, out of the heat. He suffered smoke inhalation and thought he was burned.
- FF Boatman saw FF Neveau roll onto the road. He then lost visibility due to fire and smoke impinging on the road. He did not see FF Schicke come up onto the road and no longer heard her screaming. He moved down Lumsden Road into the green, out of the heat.

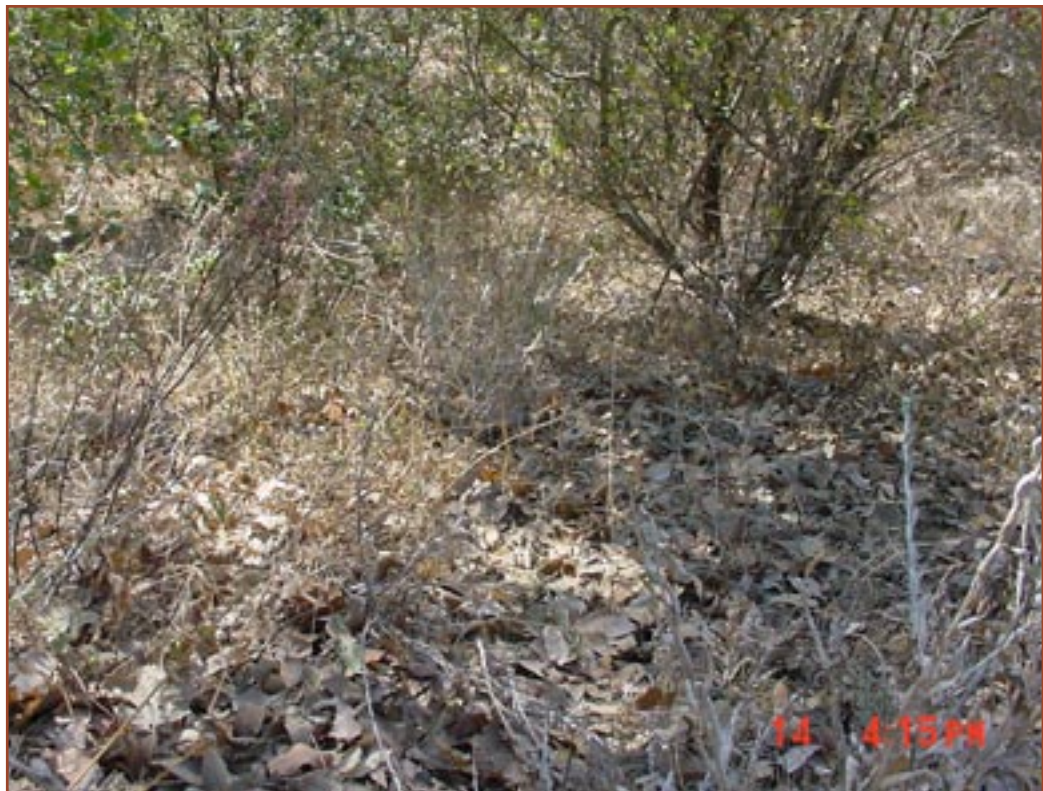
- Primary fuels burning at the accident site were light flashy surface fuels consisting of oak leaf and pine needle litter, sparse short discontinuous cured annual grass and mixed brush with an oak and pine overstory.
- Fuel remains and burn indicators in the area of the accident site are consistent with a low-intensity backing fire.
- One-hour fine dead fuel moisture was calculated at 4-5 percent for exposed fuels and 6-7 percent for shaded fuels.
- 1,000-hour fuel moisture was at a 33-year record minimum value of 7 percent at nearby Buck Meadows RAWS station.
- On-site live fuel moisture samples were taken on 9/17/04. The values recorded are for manzanita (71%) and chamise (61%).
- Energy release component (ERC) for 09/12/04 was at a record maximum value of 86.

*Photo 3.
Surface
fuels
similar to
those in
which the
fire was
burning.*

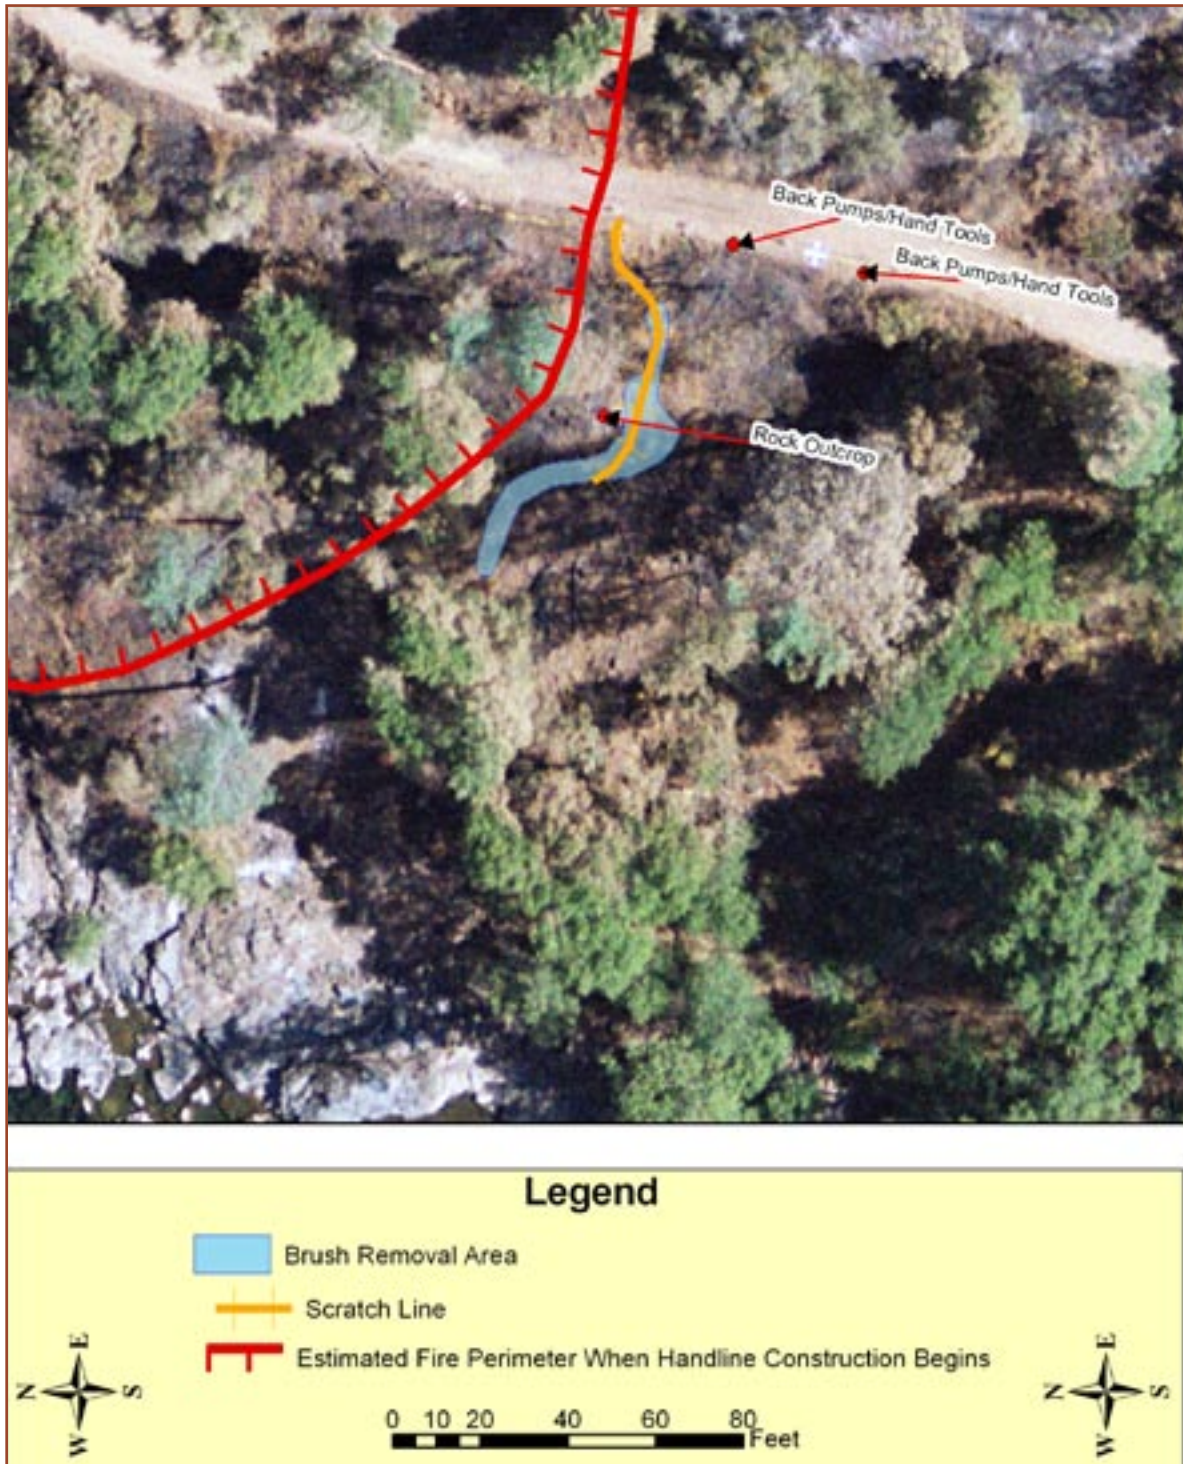
Fire Line Construction Prior to Flareup

- The short distance of unburned fuel between the fire's edge and the fireline allowed the fire to overrun the crew before they could utilize their escape routes in time. In addition, the burning fuel (particularly the brushy area below the road which presented a physical barrier) prevented the crew members from crossing the fire's edge into the black.
- Firing out of the unburned fuel from the road down was not sufficient to provide a safe fireline because it was incomplete. While firing out is an appropriate technique, not enough had been completed to be effective.

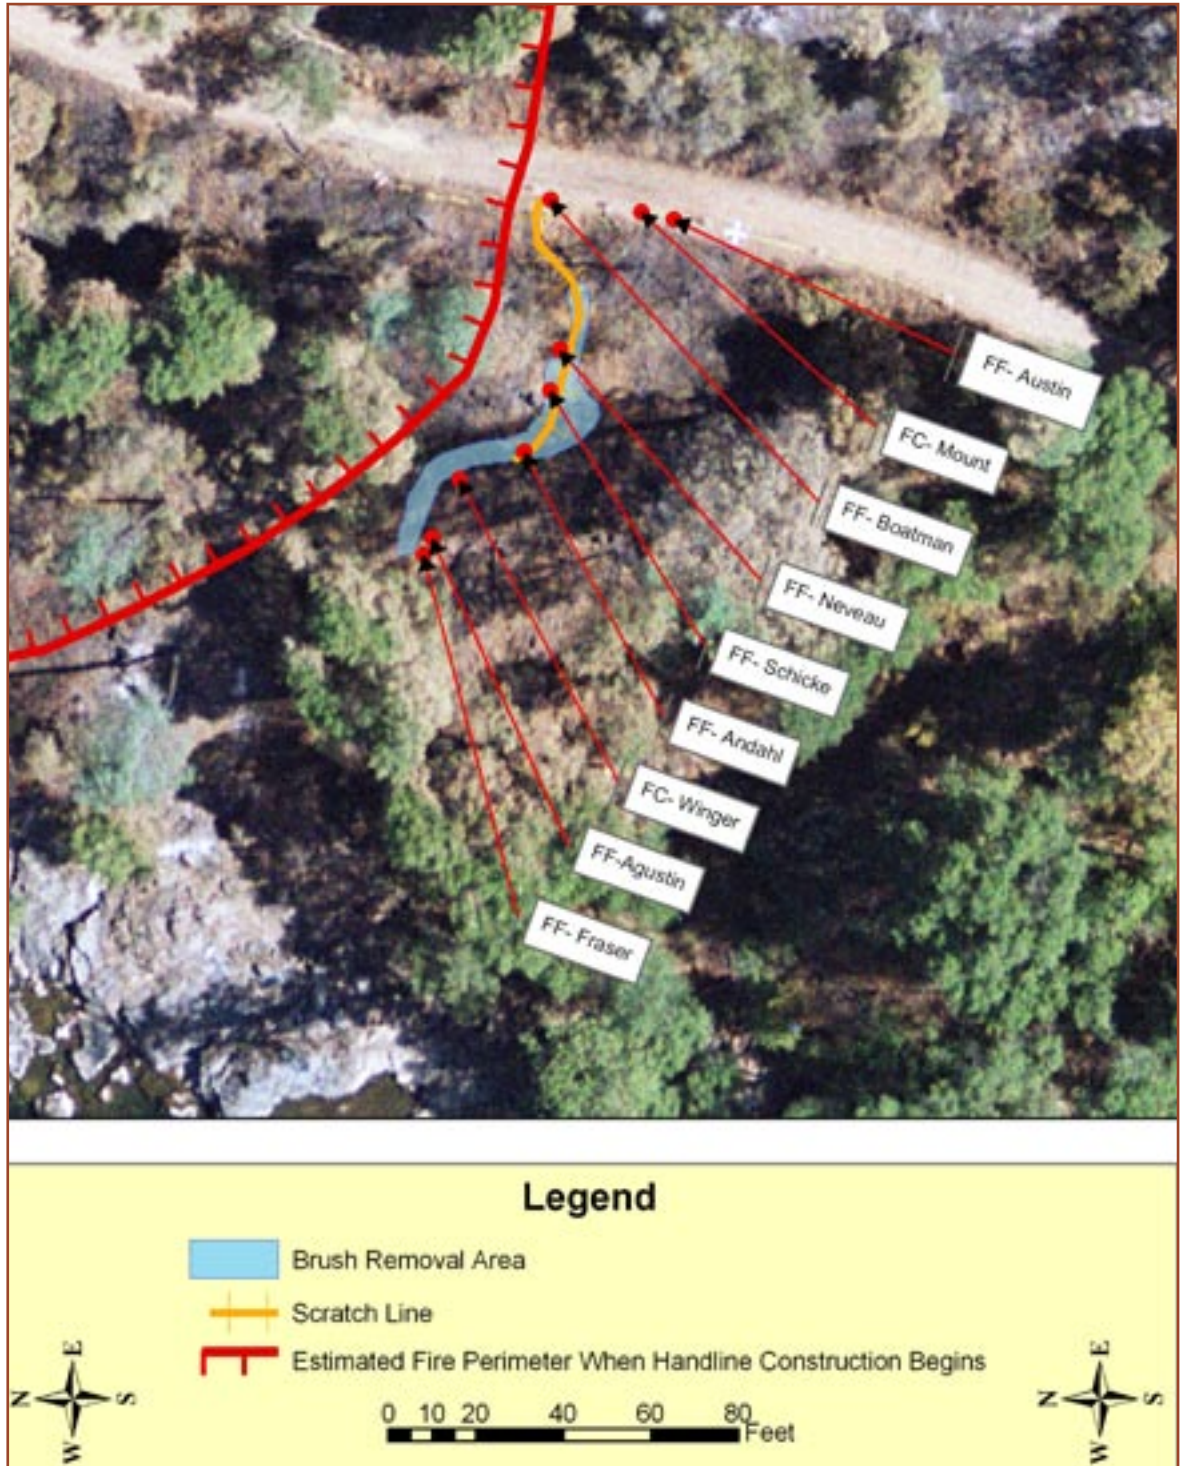
Personnel Location Prior to Flareup

- The steepness of the 80 to 120 percent slope combined with loose soil, rock out crops and drop offs made travel slow and difficult. This situation was a significant factor in the selection of the tactical options of downhill line construction.
- They did not consider withdrawing from the assignment.

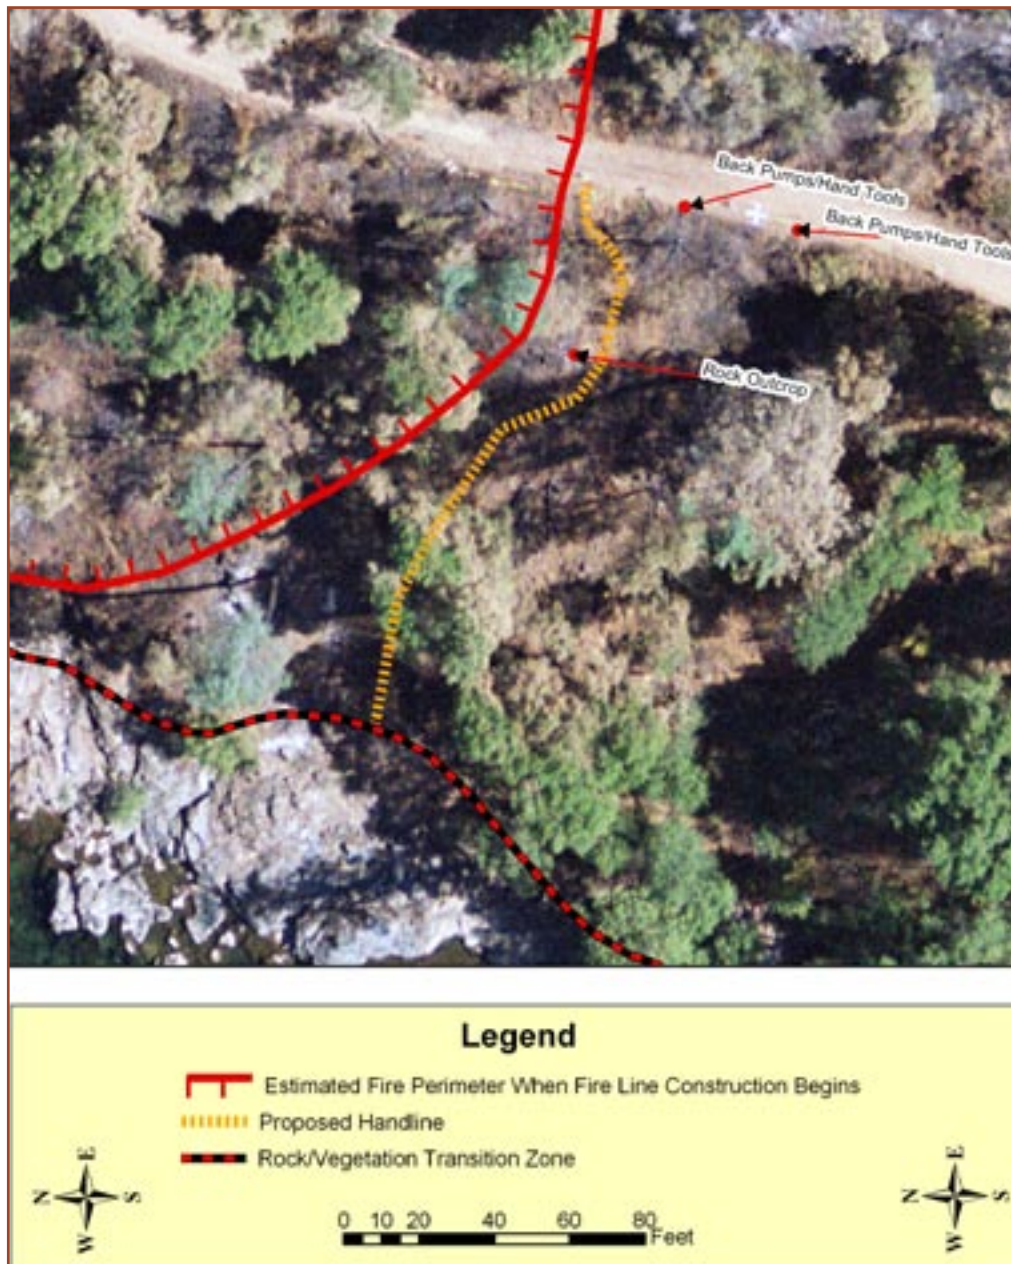
Planned Fireline Construction

Another tactic available was building direct fireline downhill. HC Winger characterized the fire as a “dirty burn.” HC Winger said that his concern was staying out of the residual heat and smoke from the dirty burn and the crew members would not be able to work from the black. There was the potential of a re-burn in the brush ladder fuels that would present a similar hazard as indirect line. They would need to use the back pumps on the steep slope. HC Winger decided that this tactic would take too much time and effort.

The tactic chosen was indirect downhill line construction parallel to the fire's edge. A reason given by HC Winger for going indirect was to keep the firefighters out of the heat and smoke of the dirty burn, take advantage of light fuels and they could fire it out as they went. They would not need to use the back pumps on the steep slope. He believed this method would allow them to build the fireline quickly.

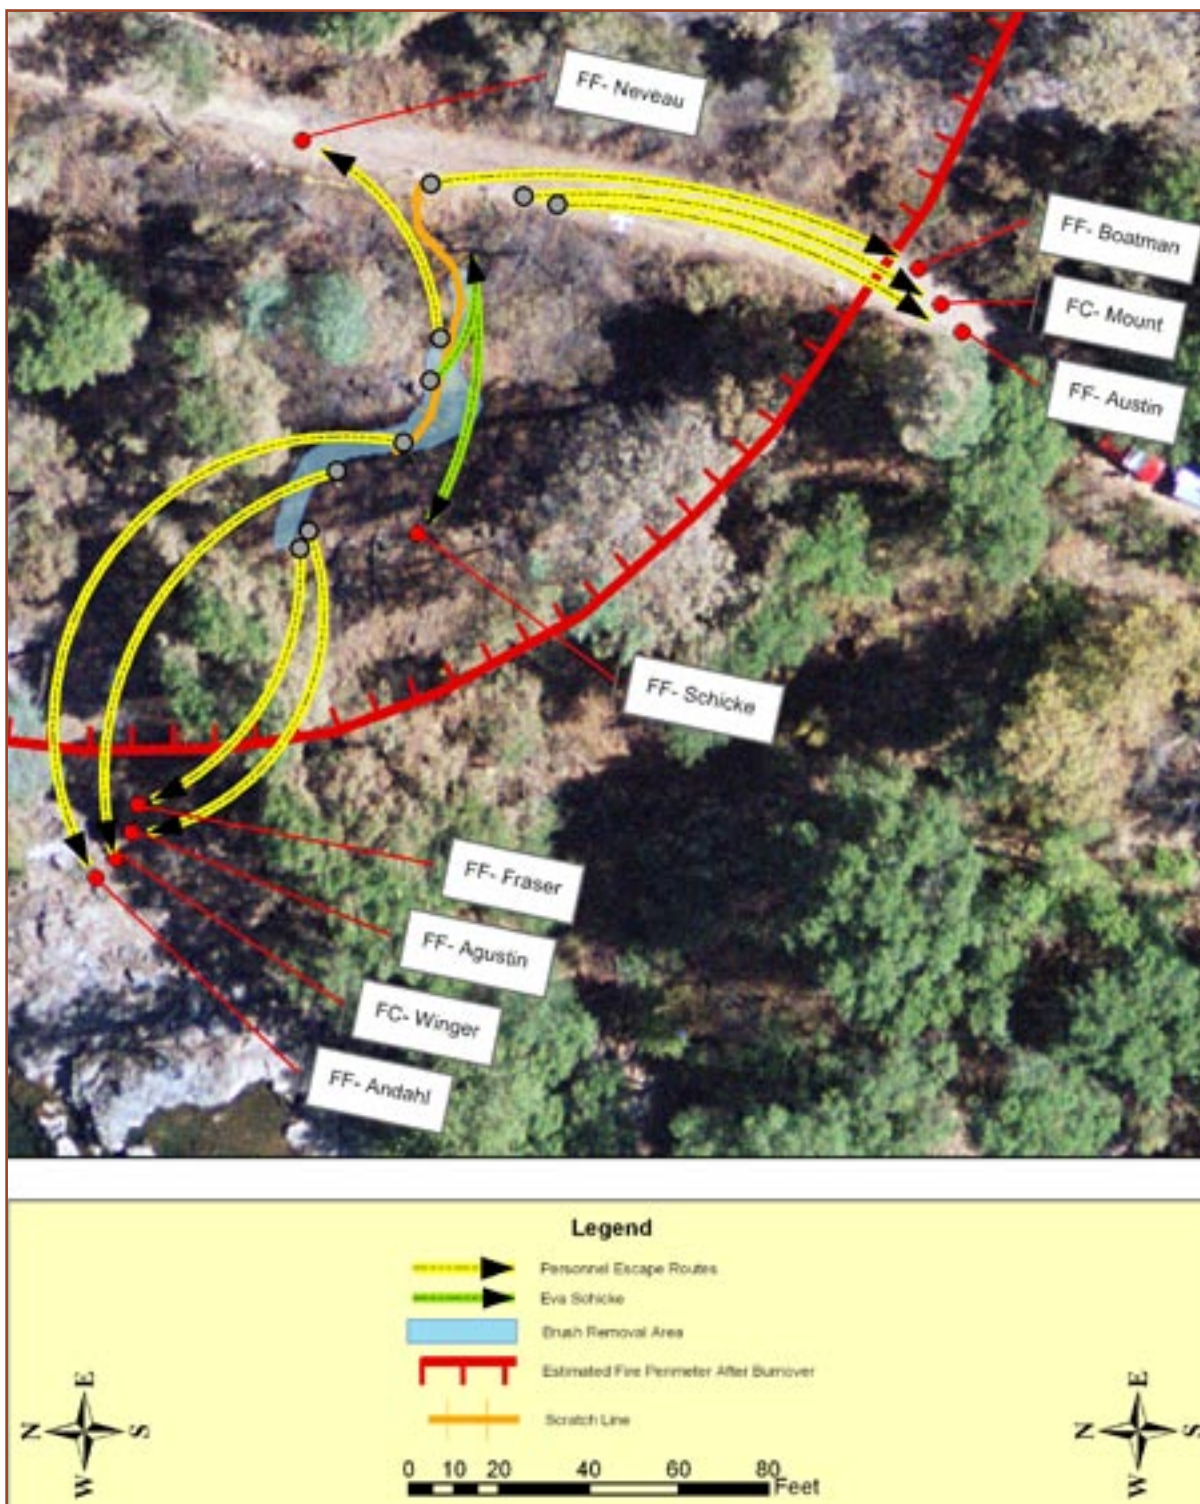
Post Burnover Crew Location

- ***The safety zone at the road was adequate, but required moving on the road into the green or into the black.*** FF Neveau reached the road and moved into the black. FF Boatman was on the road and moved into the green. Shelters were not deployed nor were they necessary. No injuries resulted once they reached the safety zone.

- ***The safety zone into the black was inadequate.*** Typically going into the cooled black is a primary safety zone. However, in this instance the black below the road proved to be too hot to remain without suffering injury. HC Winger and FF Andahl ran through flaming front into the black but believed it was too hot to stay there and turned downhill to reach the safety zone at the river. They did not deploy shelters either in the “black” or at the “river” safety zones. No injuries resulted once they reached the safety zones. Because of the flaming front and unburned fuel, escape into the black was not accessible to FF Neveau and FF Schicke.
